AD-A231 443 SSC-337

SHIP FRACTURE MECHANISMS

**A NON-EXPERT'S GUIDE FOR
INSPECTING AND DETERMINING THE CAUSES OF
SIGNIFICANT SHIP FRACTURES**

SHIP STRUCTURE COMMITTEE

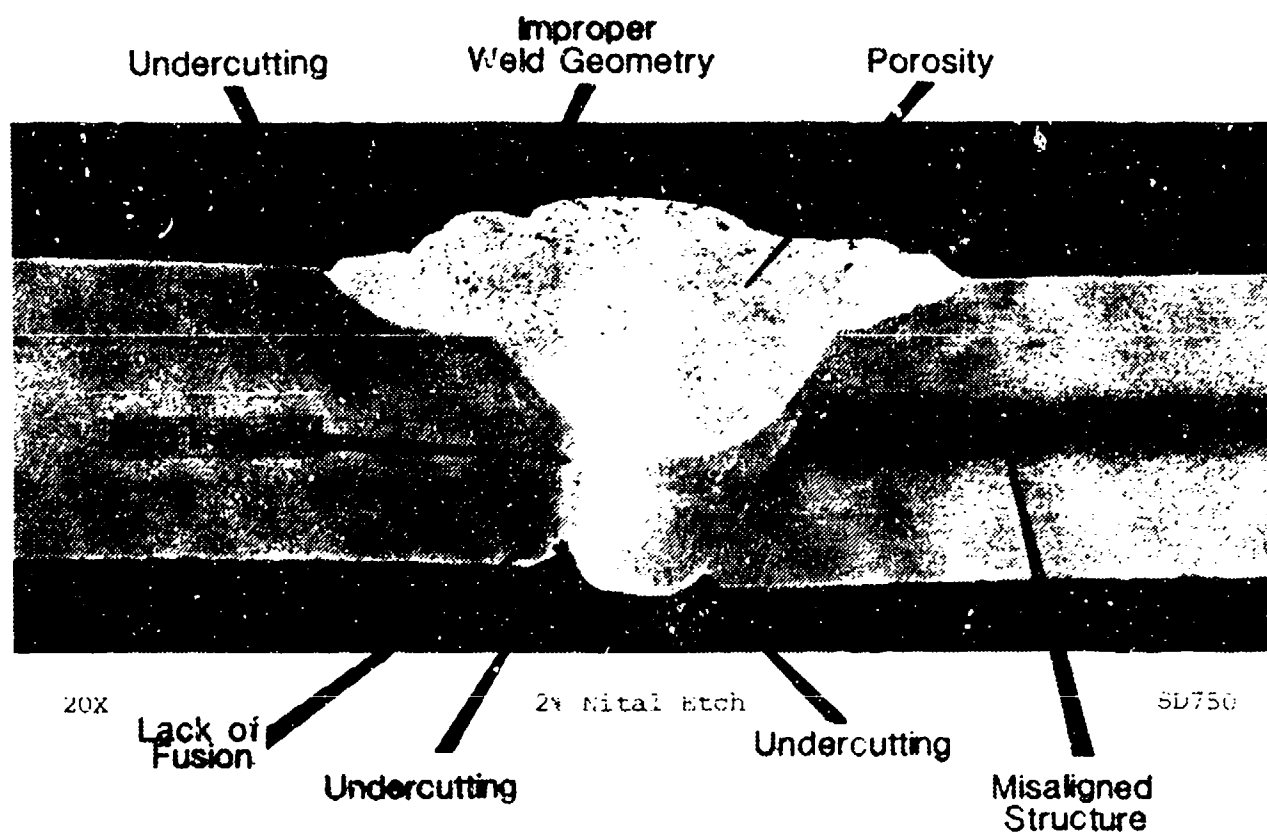
A flaw is a small defect or imperfection in the material. Flaws can be located in the base metal, the weld or the heat-affected zone. Flaws range in size from microscopic to those visible to the unaided eye. There are many types of flaws; however, most are associated with the welds or heat affected zone. Examples of flaws in welds include lack of fusion, porosity, slag inclusions, and stray arc strikes. These flaws are depicted in Figures 2-6 and 2-7.

Figure 2-6. Example of Improper Butt Weld Showing Root Bead Undercutting, Slag Inclusions, Lack of Fusion and Porosity

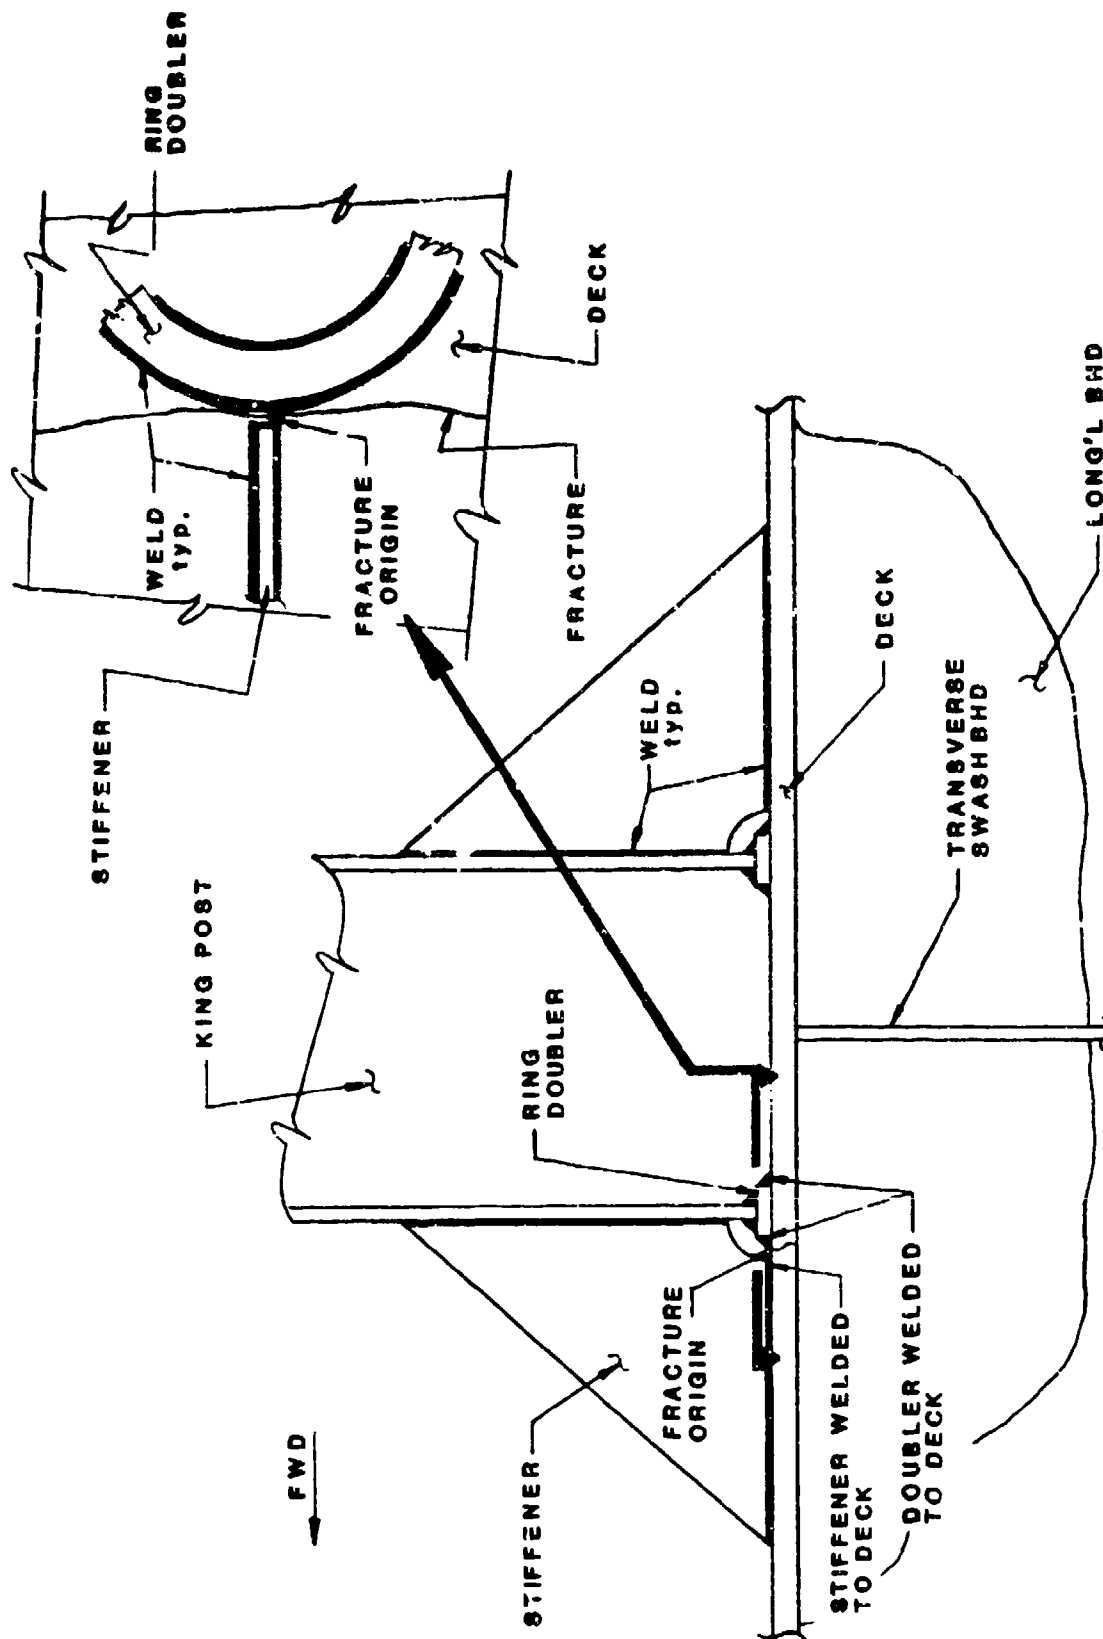
A notch is a structural discontinuity that creates locally high internal forces in the structure. Notches are usually associated with structural details or fabrication details. A structural detail is the geometry associated with structure intersections and fabrication details associated with weld geometry. A notch is produced by undercutting at a weld edge as shown in Figure 2-6, by placement of two welds too close together as shown in Figure 2-8, or by sharp internal corners as shown in Figure 2-9.

Figure 2-8. Illustration of the Notch Effect Caused by Fillet Weld

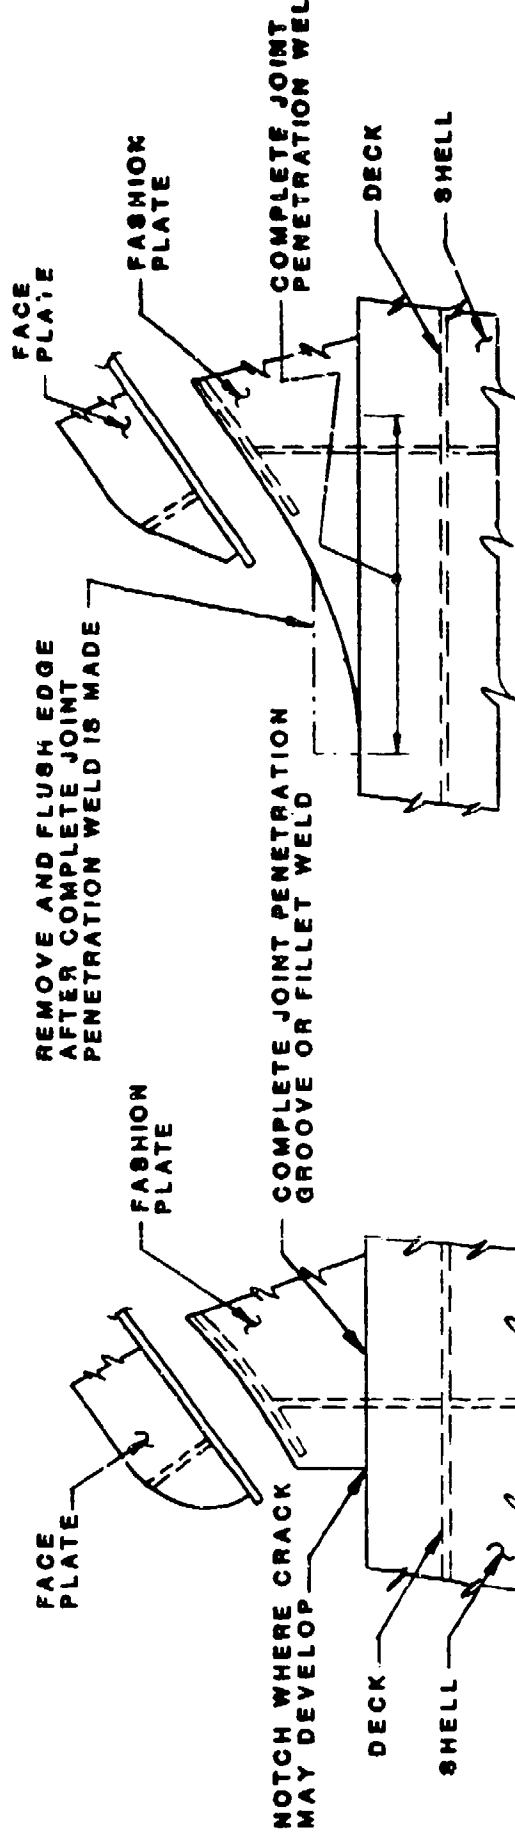
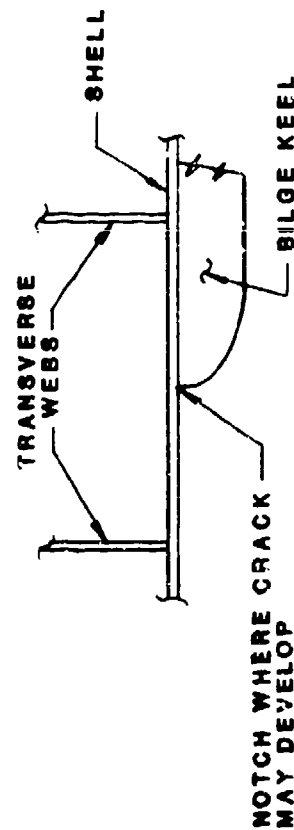
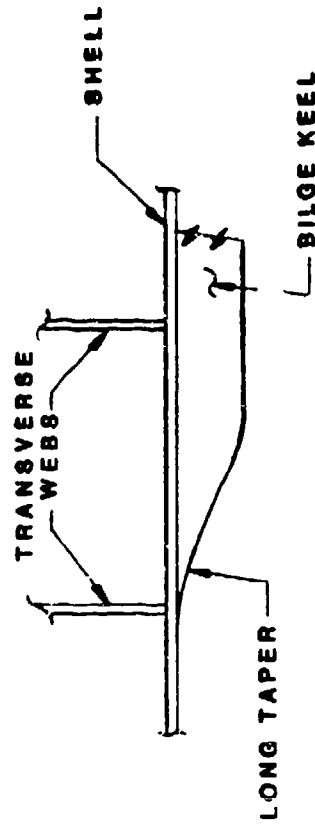
Poor Design

ENDING OF BULWARK FASHION PLATE WELDED TO TOP OF SHEERSTRAKE

BILGE KEEL ENDINGS

Figure 2-9. Illustration of the Notch Effect Produced by an Internal Corner

Improved Design

Good Design

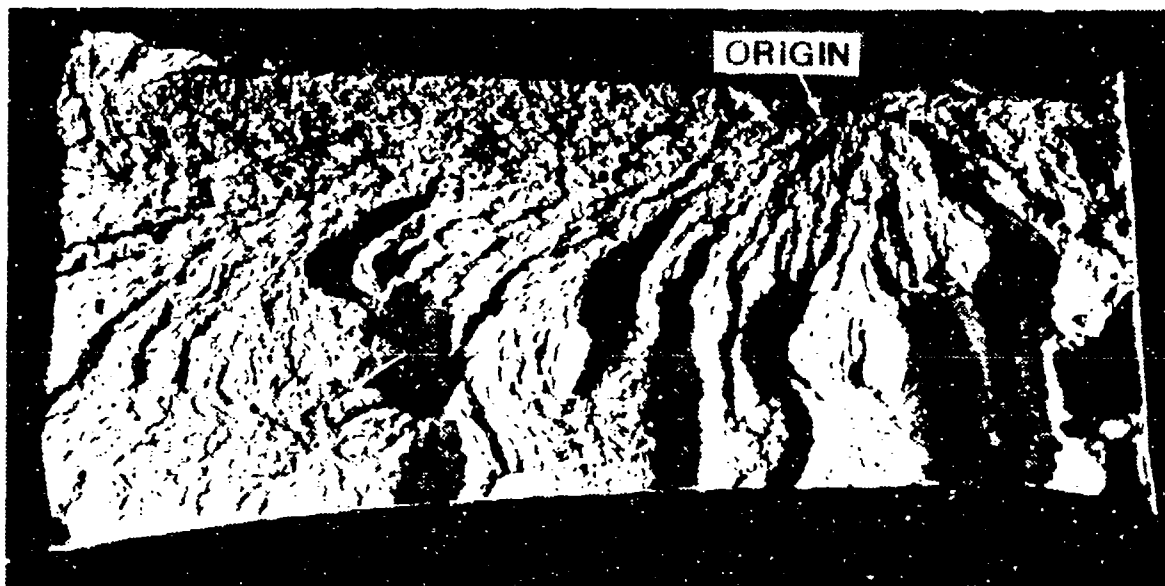
You will be able to locate the origin of a fracture by following the points of the distinctive chevron marks to the origin. The apex of the chevron marks points to the location where the fracture originated. Figure 2-10 illustrates this important feature of significant fractures. Note that the fracture origin is not necessarily at the ends of a fracture, but may be in the center of the fracture. In this case the fracture propagates in two directions, away from the origin. Often the chevron marks will appear near the origin and in other instances they will be less distinguishable at the origin; however, lines will radiate from the fracture origin as shown in Figure 2-11.

Figure 2-11. Fracture Surface at the Origin of a Significant Fracture at a Weld Crack

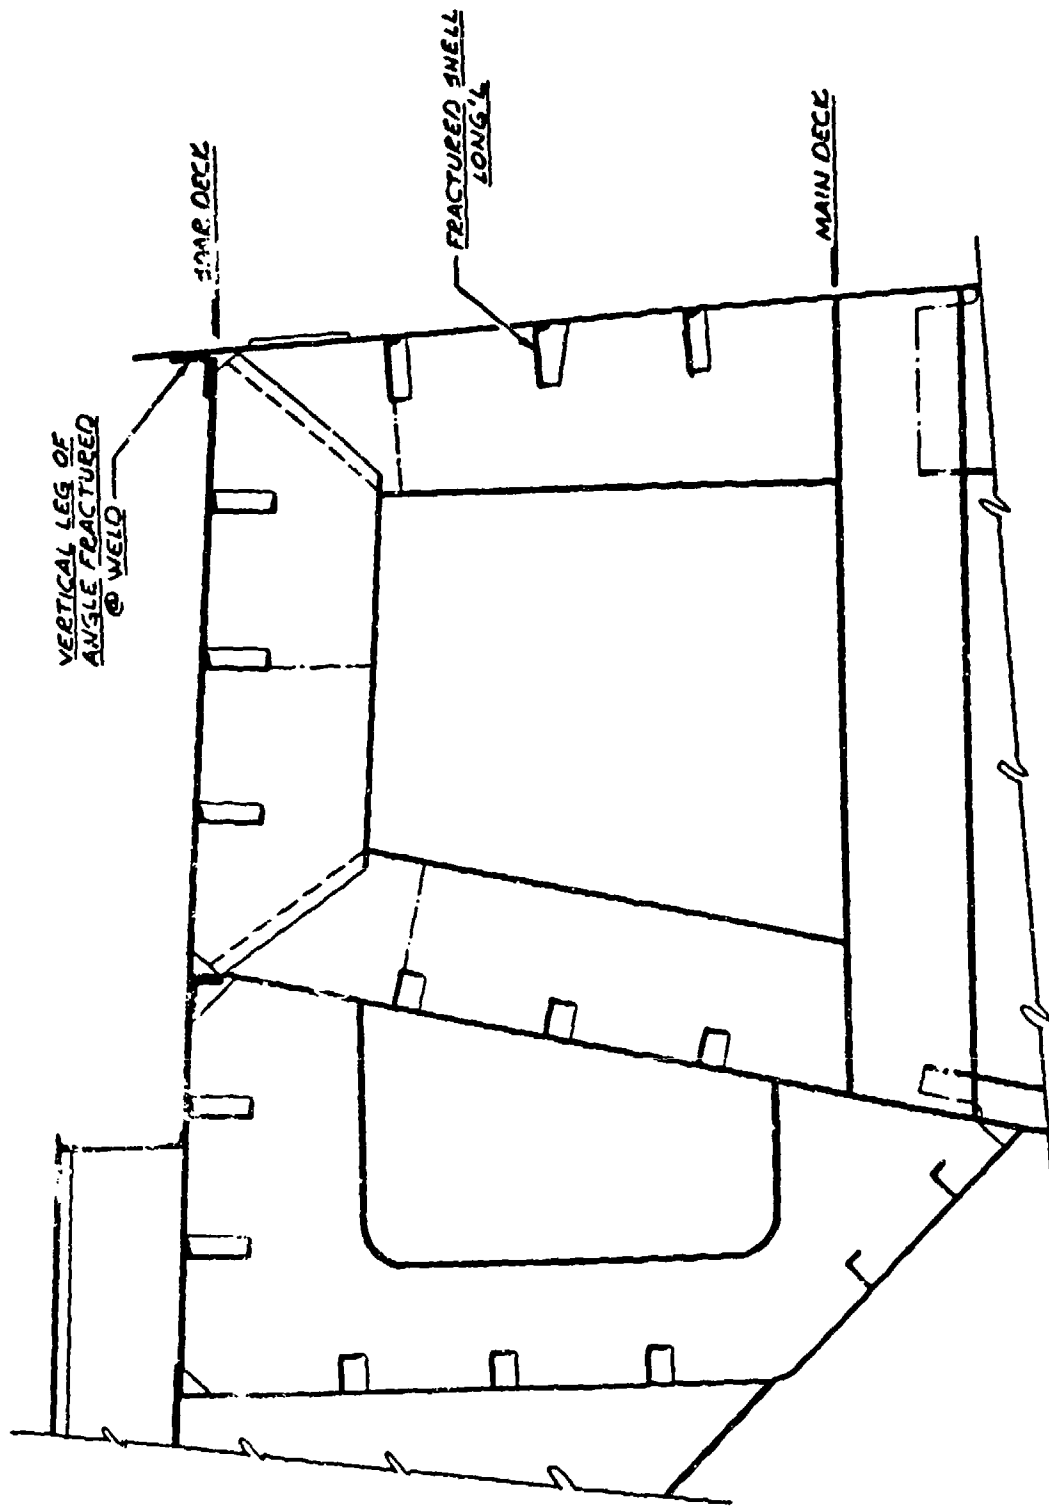
SKETCH D
WED FEB 11/8

Figure 4-2. Section of the Upper Wing Tank of the Great Lakes Bulk Carrier
